# Manhole Inspection Summary

Manhole # S17KK\_009MH

Insp Date: **3/3/09 12:45 PM**

**Location** Address: **2228 HERBERT ST**

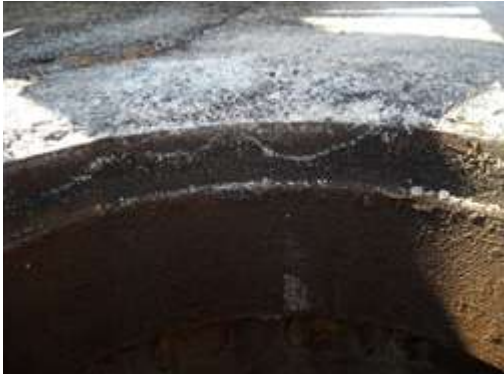
EVIDENCE OF INFLOW DUE TO  
SHEETING FROM ALLEYWAY

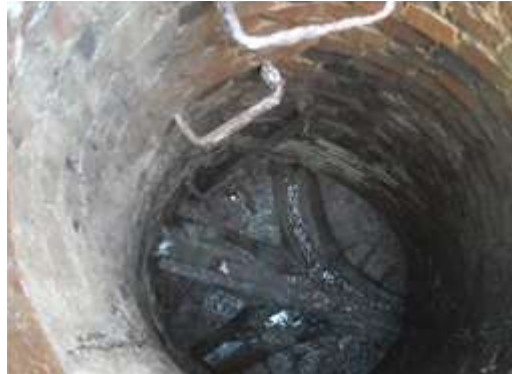
Defect 4

DEBRIS ON BENCH GOES INTO STEPS

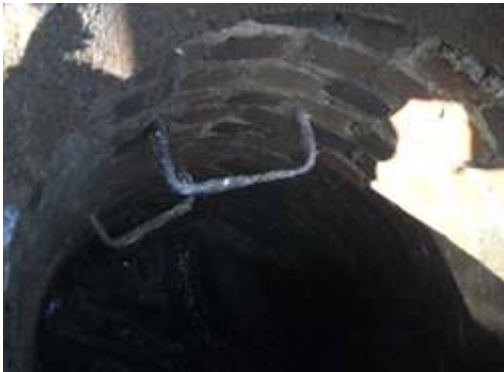
Defect 3

CORRODED STAIRS

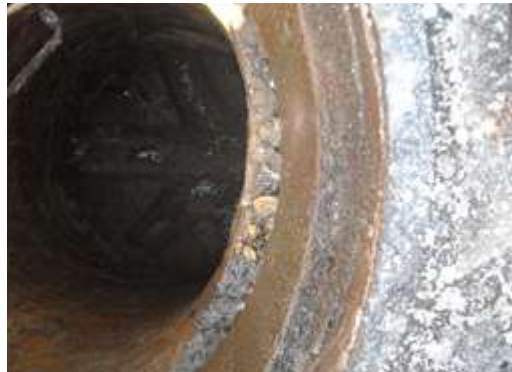
Defect 2

FRAME OFFSET 2"

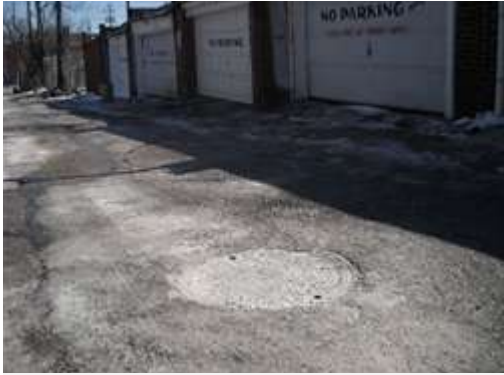
Defect 1

MANHOLE SITS IN ALLEY BELOW GRADE

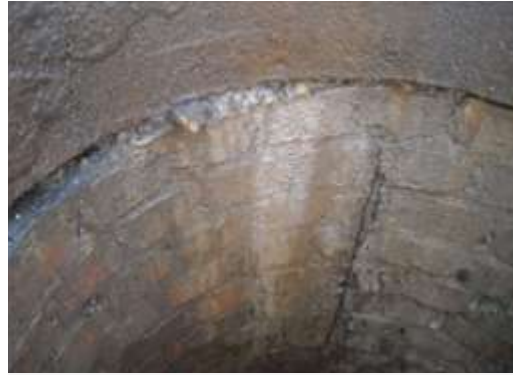
Defect 6

EVIDENCE OF INFILTRATION BELOW FRAME AT FRAME/CHIMNEY JOINT

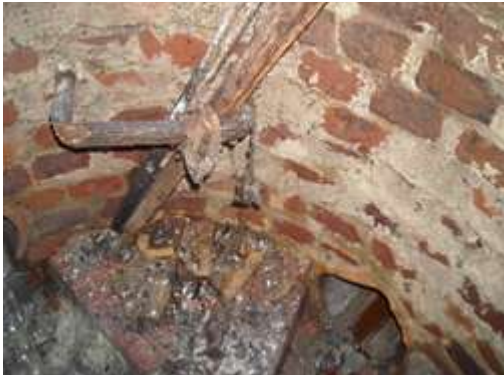
Defect 5

DEBRIS IN MH
